University of Auckland
Department of Civil and Environmental Engineering
BE(Hons)

Fire Engineering Investigation of a Cold Formed Steel Framed House Fire

By Rohit Pantham

13/02/2013

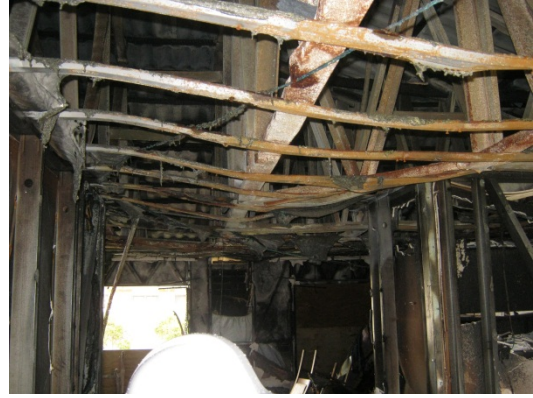
Figure 2: Living room showing distortion of the steel roof trusses and ceiling battens

The steel framing in the ceiling was visibly distorted but in the walls, the steel was shiny and had very little distortion over most of the visible framing, with localised regions of surface dulling and very small distortion. This implies that the firemen suppressed the fire just when the wall lining was about to fail. The 10mm wall lining was not there in the pictures and so it was assumed that either the firemen had pulled the damaged wall lining out once the fire had been extinguished or the hosing down of the fire had taken the lining off. The roof was supported by wooden battens and this was one of the only places in the house where timber was used as construction. From Figure 14 below, it can be seen that the battens were charred due to the high temperatures.

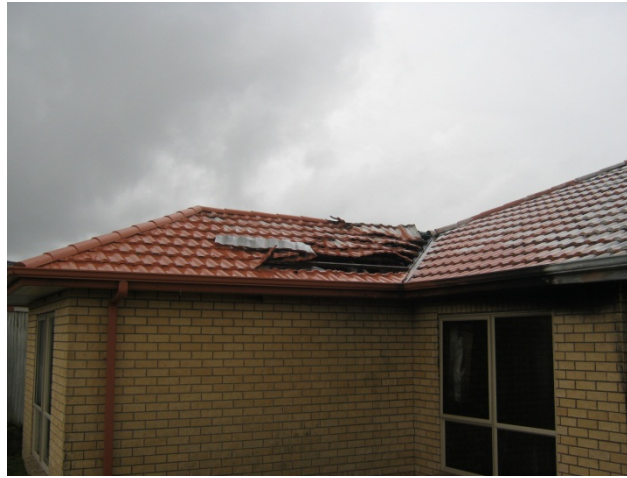
Figure 6: Hole in the roof from the East Elevation of the house

An important point to mention is that some of the roof appears to have been pulled back by the firemen; this meant that the shape of the actual hole during the fire would have to be smaller than what was seen in this picture. So, using the Floor Plan, an approximated shape as seen in Figure 5 was drawn and dimensions were measured to scale. This allowed the area to be calculated and used as A_h . Furthermore, the A_h was assumed to act at the ceiling height in the enclosure area shown in Figure 3.

The change in ventilation occurred when the ceiling had failed. That is, when the hole in the roof was formed. It is important to note that the hole in the ceiling occurred above Bedroom 4 as per the Floor Plan (refer to Appendix). It did not occur above the critical area consisting of the kitchen/dining/lounge. This was due to the fact that once the lining in the ceiling had failed, the fire moved to the roof cavities and generated high temperatures within the cavity above the opening. However, as the only combustible material in the ceiling cavity was the timber roof battens, the fire could not spread through the roof cavity and back down into adjacent rooms. Calculations were made to take into account this change in ventilation and the respective time-temperature curves were produced.

- The lining in the ceiling had failed before the wall lining, causing a hole in the roof
- The hole in the roof did not occur directly above the point of ceiling failure due to the orientation of the roof above the enclosure of origin; rather it occurred at intersecting roof lines where restraint of thermal expansion caused openings to develop.

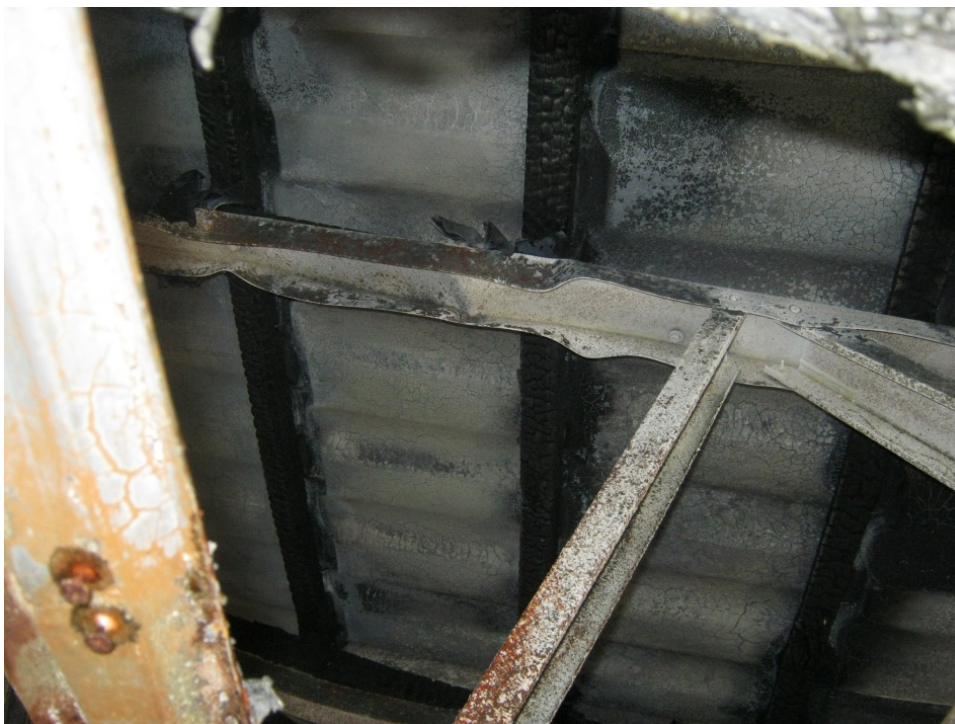
Figure 14: Image showing the charred battens

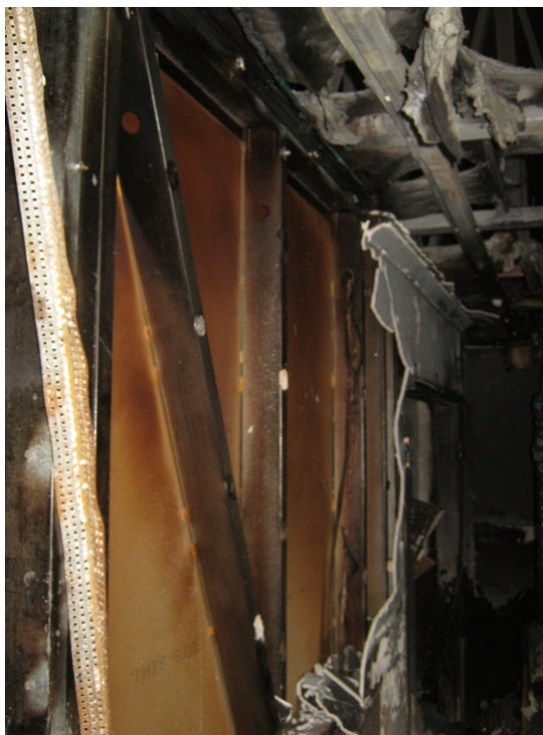
Also, the steel framing can be seen to be distorted heavily but still intact. It is, however, important to note that there was only distortion of the steel framing in the roof. The framing in the walls were well intact and had little to no signs of exposure to high temperatures and distortion. This observation can be seen in the picture below:

Figure 15: Undistorted steel framing in the walls

In Figure 15 it can be seen that the steel framing in the walls are 'fresh' and shiny. There are little patches of dark spots on the wall framing indicating that the wall lining had failed at these points but since the patches are relatively small there is little to no distortion.
