LIGHT STEEL-FRAMED HOUSE GETS THE EARTHQUAKE TEST

Tests show that brick veneer steel-framed houses should perform very well in earthquakes.

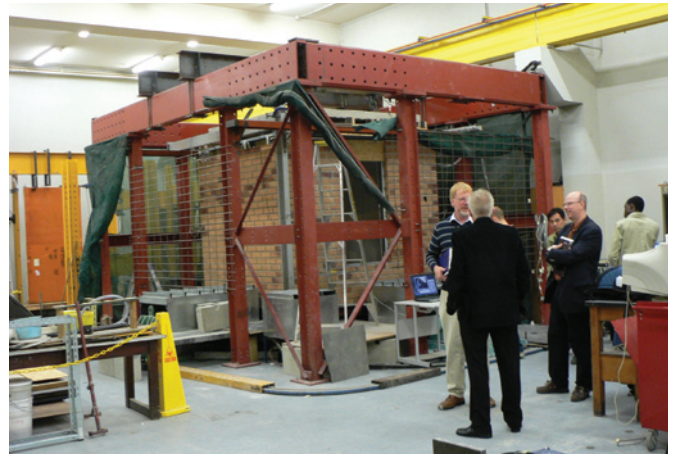
Test house on shaking table prior to test.

Graham Rundle of Redco (NZ) Ltd designed the test house. It measured approximately 2.6 × 2.8 m in plan and 2.4 m in height. It had a light steel frame with brick veneer exterior cladding and plasterboard interior lining. The steel frame was manufactured from 0.75 mm thick G550 lipped C-sections. The bricks were standard 70 Series with Type B brick ties.

The ties were screwed to the flanges of the studs through a standard 40 × 10 mm thick thermal break. The front and side walls were separated at the corners, in order to simulate long brick veneer walls. A roof slab weighing 1,500 kg was placed at the top and was supported by the frame to simulate the equivalent mass from a house roof. The result was that the test house exhibited the same dynamic characteristics as those of a typical full-scale single-storey brick veneer house. It had a fundamental natural frequency prior to earthquake shaking of approximately 6 Hz.

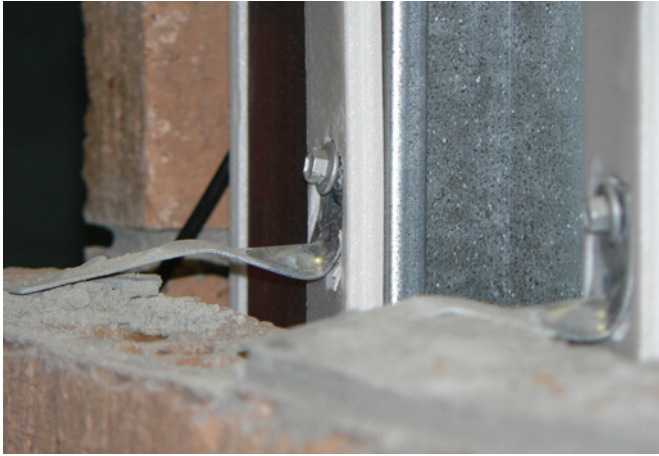
Permanent deformation of brick ties at end of tests.

The house was then subjected to even more severe shaking. It did not suffer serious damage up to and including 2.6 times El Centro, with no bricks being lost from the out-of-plane walls. This is an extremely good performance given that the house had already been subjected to seven high-level earthquakes. The testing was terminated after a final shake equivalent to 2.7 times El Centro (1.57 times the maximum considered) because the capacity of the shaking table had been reached.

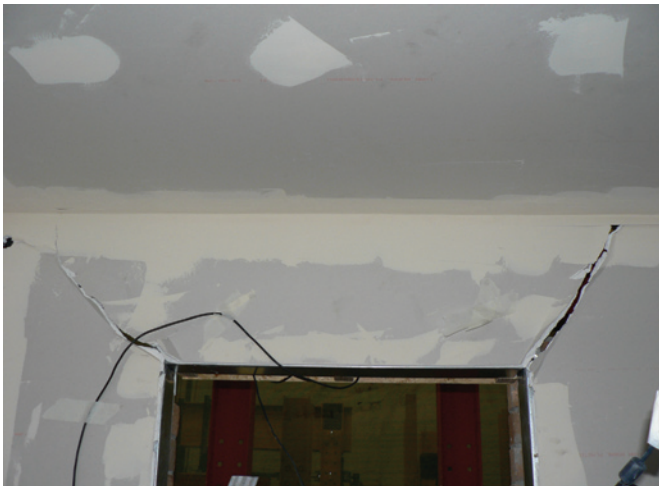
Internal lining damage at maximum load.

The house performed extremely well, with the maximum considered levels of shaking only causing minor cracking to the plasterboard and brick veneer walls (even though, at this level of loading, major loss of the veneer walls is acceptable).
