**Faculty of Engineering and Industrial Sciences
Smart Structure Laboratory**

Study on Thermal Behaviour of an External Residential Wall Panel

Report prepared for:
NASH NZ

21 July 2013

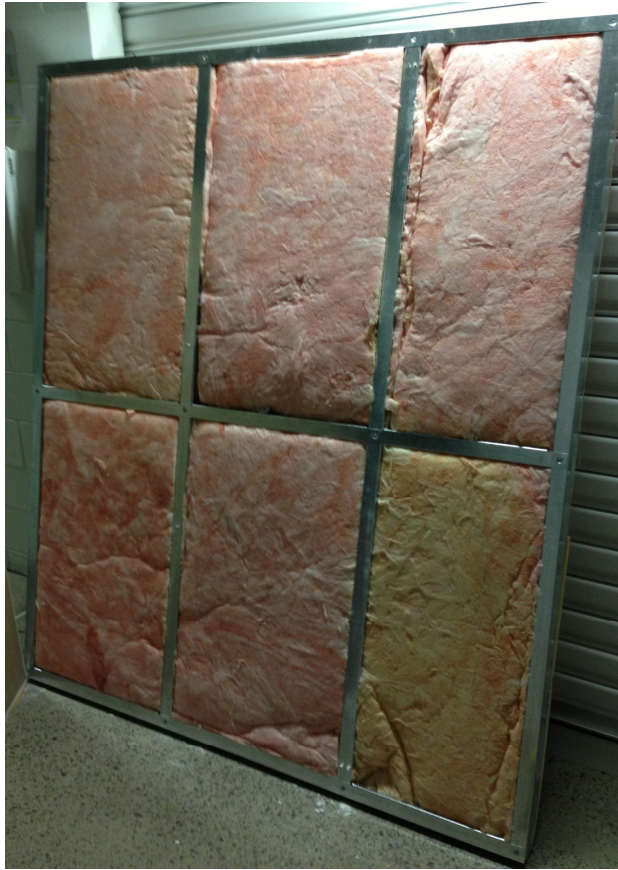
Figure 2: Steel frame with the insulation pink batts.

The steel frame was made of top and bottom plates, four studs and one row of noggings at mid-height. The frame was supplied by Axxis Steel with all members made from 0.75mm thick 90mmx40mm lipped C sections G550 Z275 steel. Figure 2 shows the steel frame with the infill insulation batts.

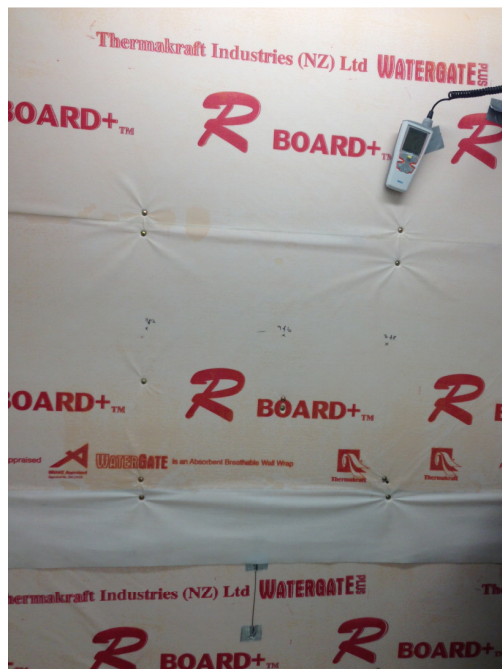
Figure 3: Appearance of Watergate Plus wrap.

The wrap used for the test wall was Watergate Plus which is produced by Thermakraft Industries (NZ) Ltd. Watergate Plus is breathable, absorbent, flexible, synthetic wall underlay for use under direct fixed and non-direct fixed wall cladding on timber and steel framed buildings. For the test panel, the wrap was already glued to the XPS thermal break. Figure 3 shows the appearance of the wrap.

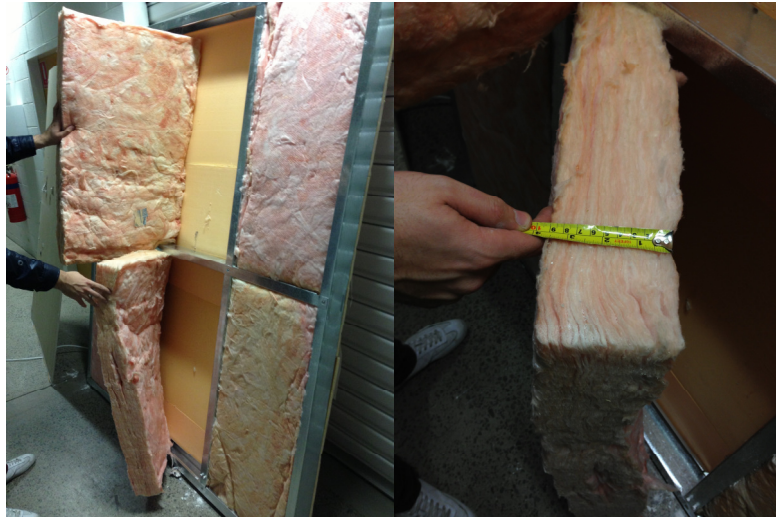
Figure 5: Pink batts used for the test panel.

The insulation batts used for the test wall were R2.6 Ultra wall pink batts as shown in Figure 5.

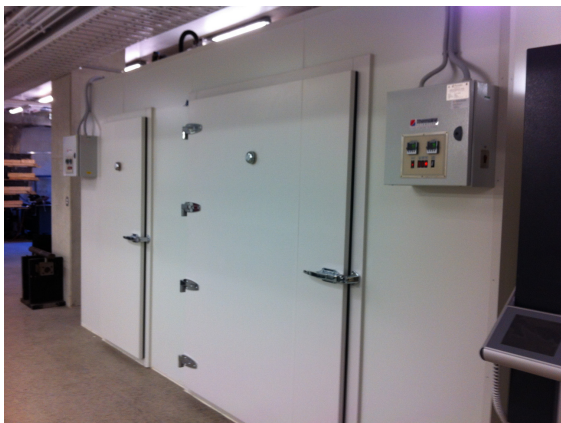
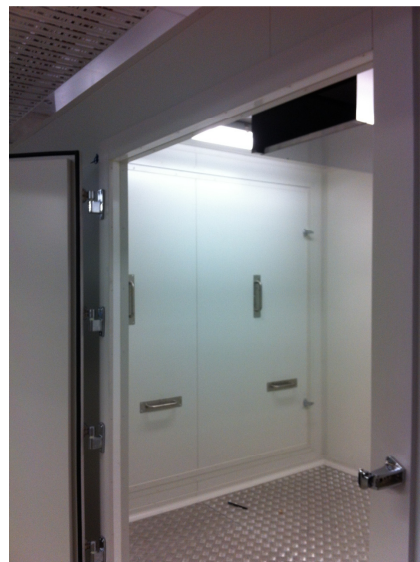
Figure 6: Photos of the environmental chamber used for testing: (a) exterior of the chamber showing the two access doors; (b) interior view showing the removable partition.

The environmental chamber where the tests were conducted is shown in Figure 6. This chamber has two rooms with separate temperature and humidity controllers. The two rooms are separated by an insulated removal partition with each room having its own door access.

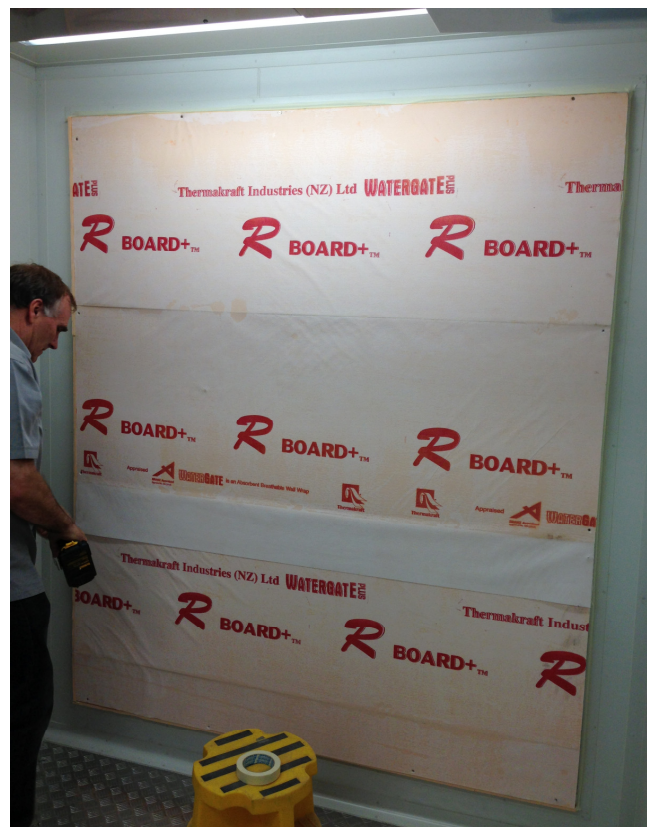
Figure 8: Photo of the wall test panel in the chamber.

For this test the removable partition was replaced with the wall test panel. The rooms within the chamber were designated Hot Room which was used to simulate interior conditions in a house and Cold Room for exterior conditions as shown in Figure 7. In this setup, the plasterboard side of the wall was facing the Hot Room and the wrap side of the wall was facing the Cold Room. Figure 8 shows a photo of the wall in the chamber during its installation.

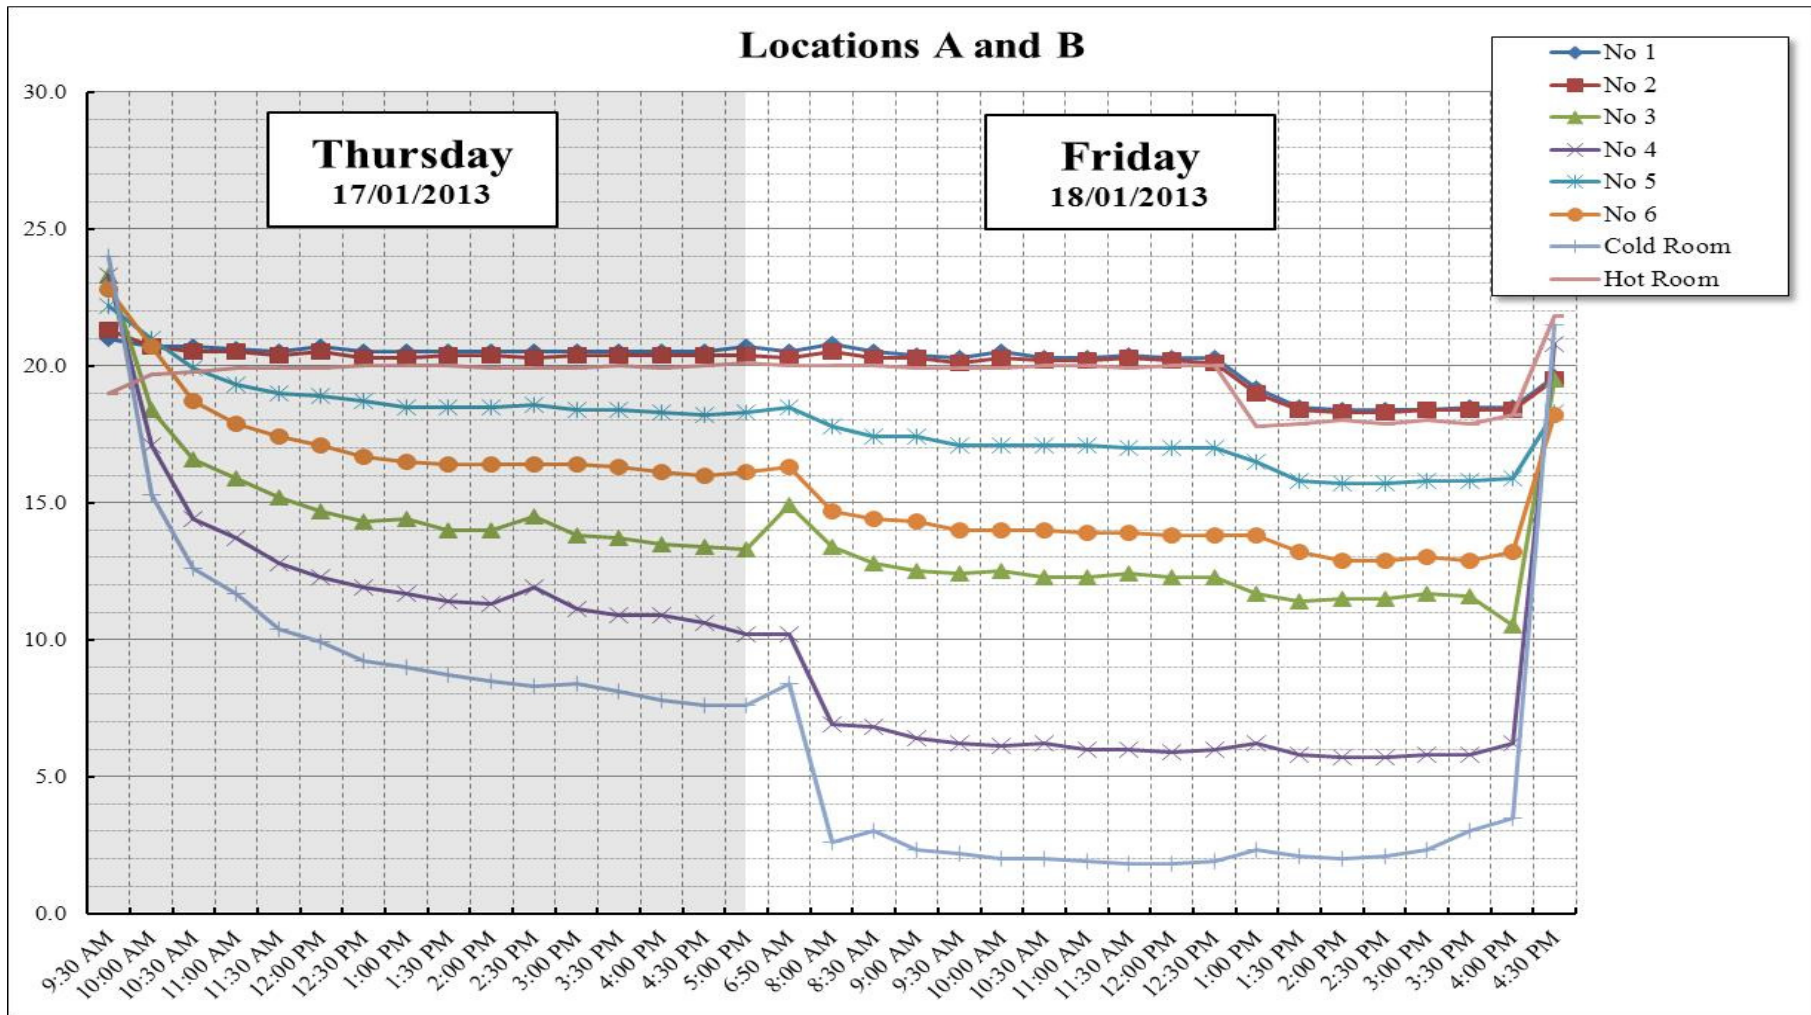
Figure A1: Thermocouple readings for Test Program I at locations A and B (refer to Figure 9 for location details)

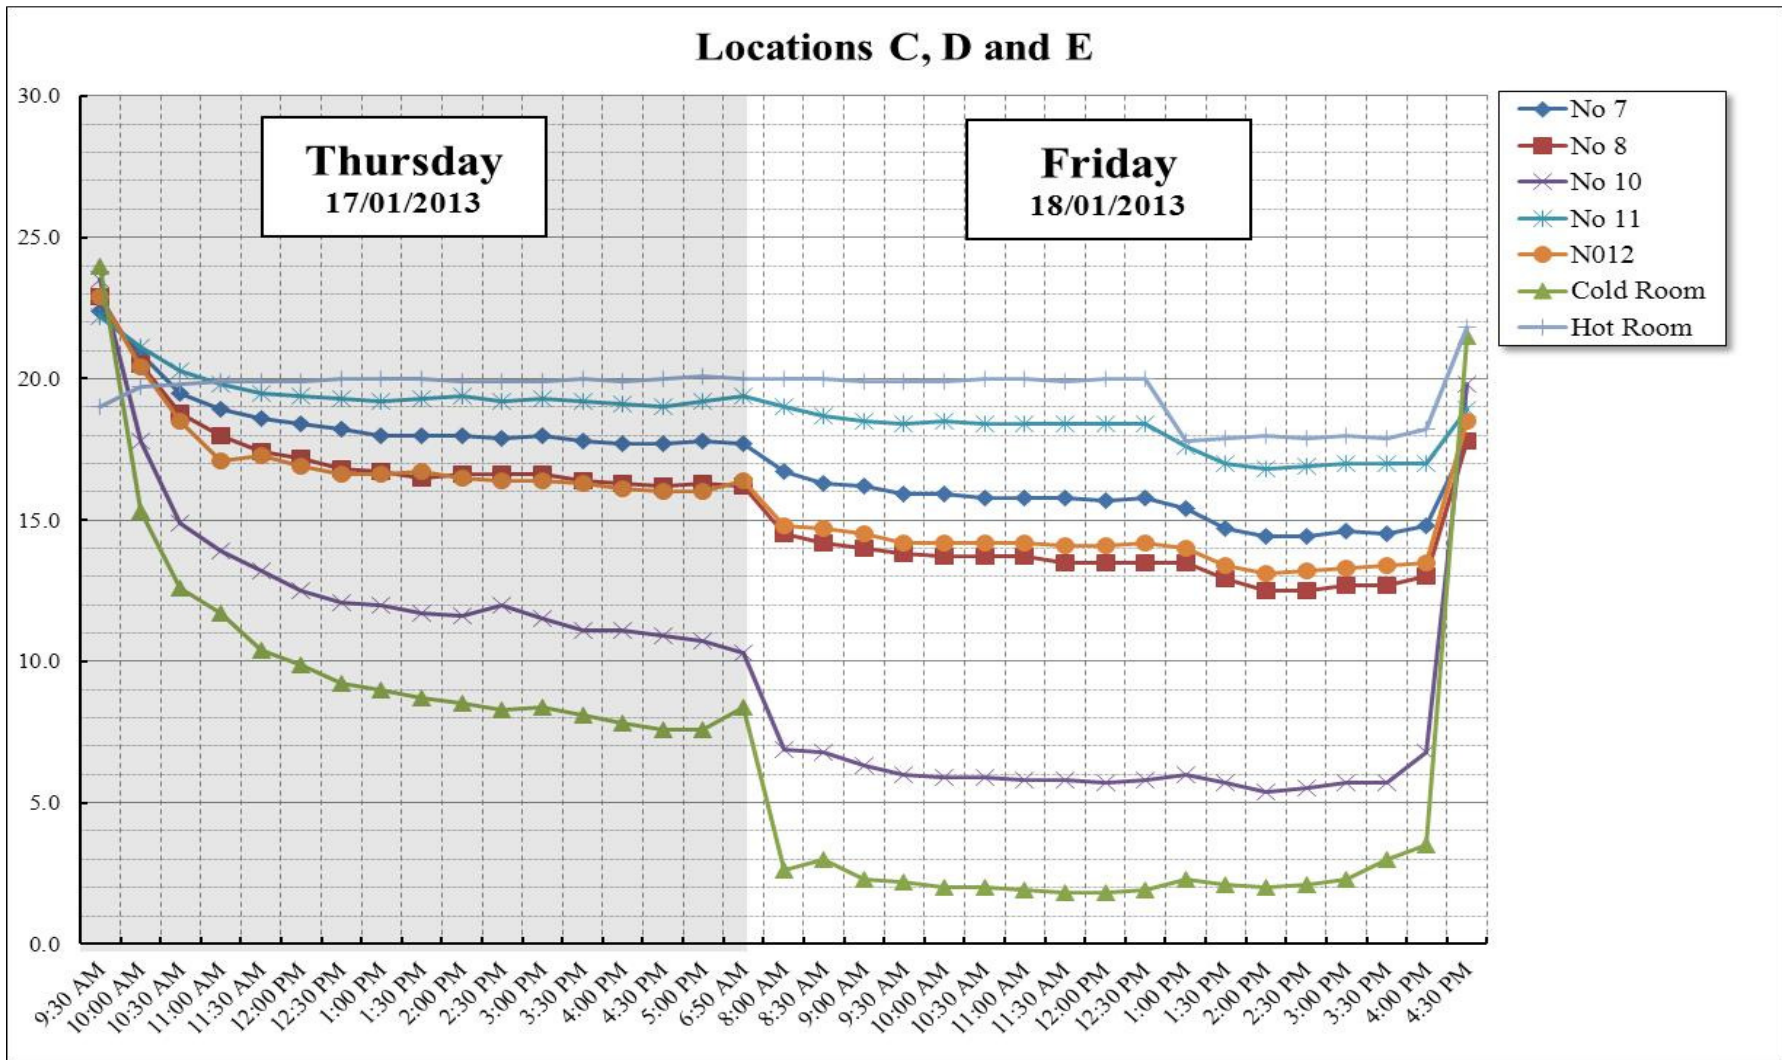
Figure A2: Thermocouple readings for Test Program I at locations C, D and E (refer to Figure 9 for location details)

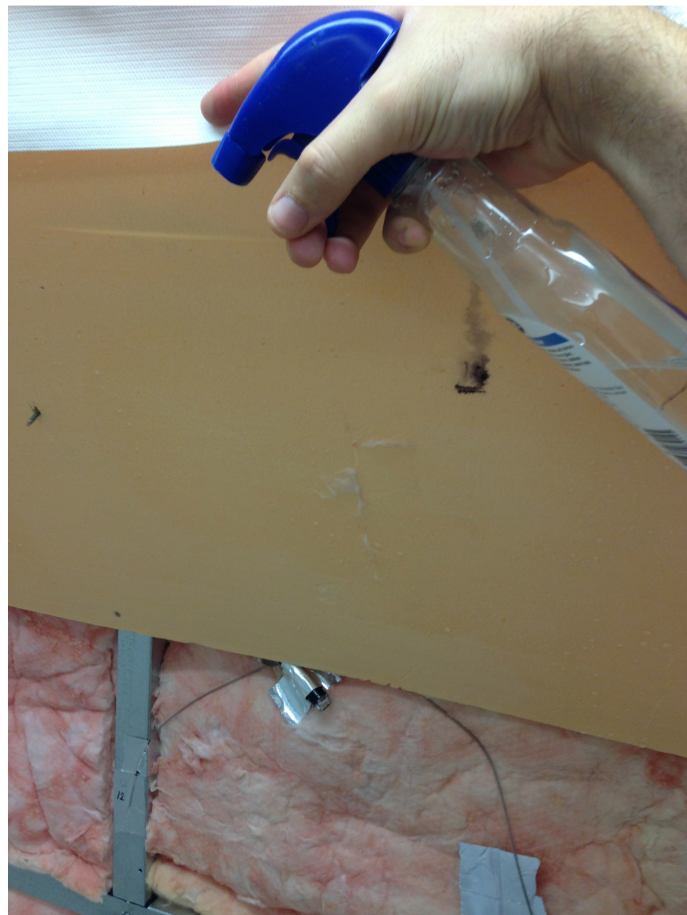
Figure B2. Spraying water to insulation batts and XPS foam

The test started on Monday 5/2/13 with one cycle of day and night temperatures before spraying 192ml of water on the XPS sheet and adjacent pink batts between the two intermediate studs on Tuesday 6/2/2013. These cycles were maintained for 3 days until Friday 8/2/2013. Until that time, moisture was still in the wall. It was decided for the weekend (9/2-10/2) to maintain an average temperature in the Cold Room of 6°C which is the average between 3°C and 10°C until Monday 11/2. However, upon inspection on Monday 11/2 it was found that lowest temperature in the Cold Room was 11°C. Due to malfunction of the conditioning unit of the Cold Room, the temperature could not be lowered than 10°C. Hence, the Cold Room temperature was maintained at about 10°C until the wall dried out completely. This occurred on 14/2/13, eight days after the spraying of water.

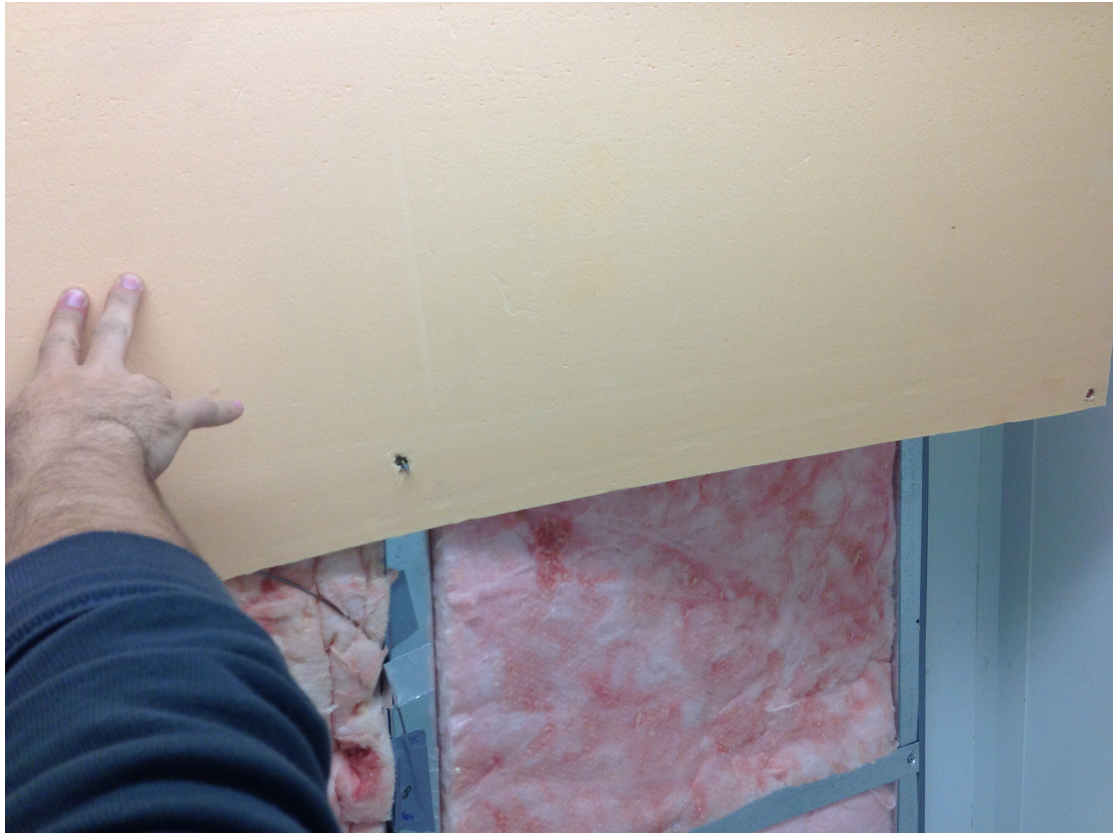
Figure B9. Eighth day check (Completely dry)
