University of Auckland
Department of Civil and Environmental Engineering
BE(Hons)

Fire Engineering Investigation of a Cold Formed Steel Framed House Fire

By Rohit Pantham

13/02/2013

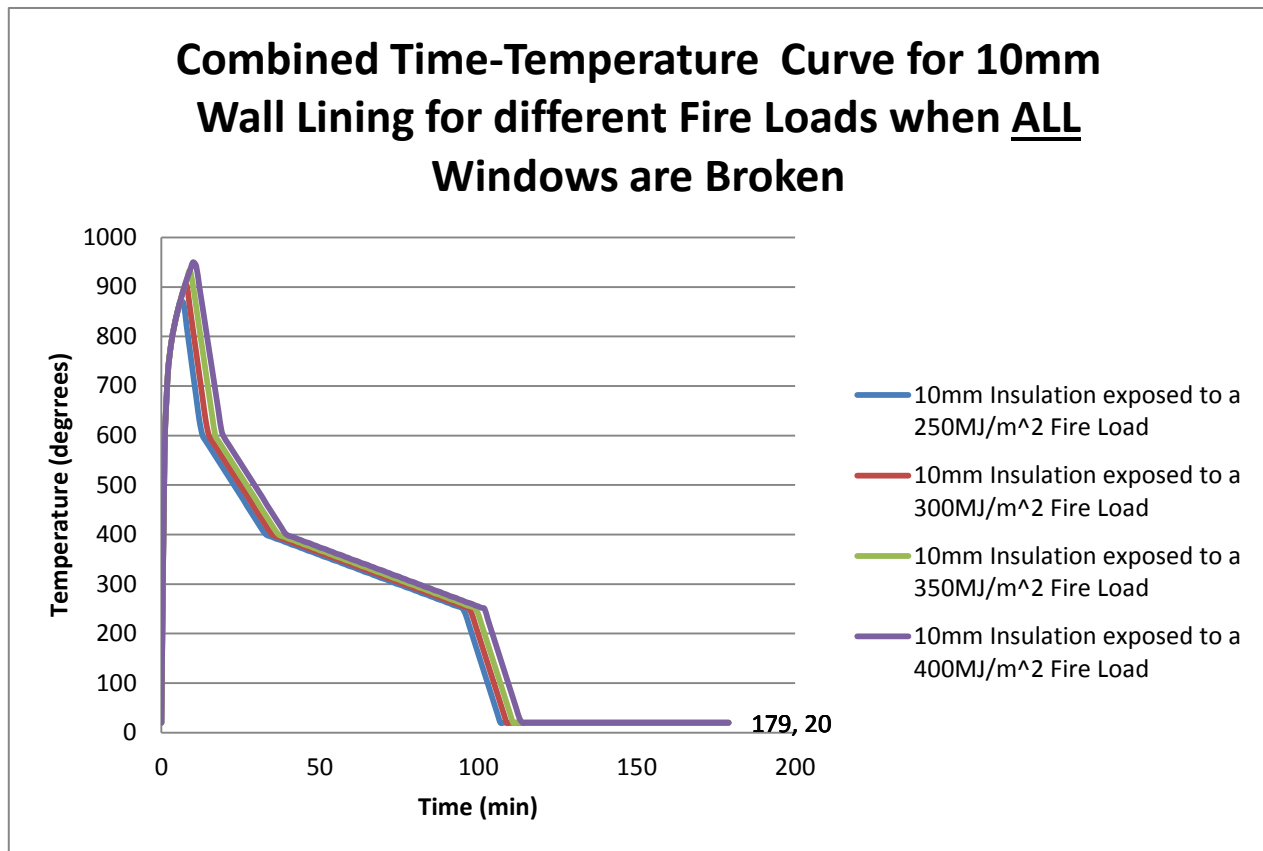
Figure 7: Time temperature curves and failure times for the Wall Lining when all windows are assumed broken

Figure 7 shows the time-temperature curves for the 10mm wall lining and failure times of both the 10mm and 20mm wall lining for different fire loads, when all the windows are assumed broken. It can be seen that as the fire load increases, the maximum temperature of the fire increases as well. The curves also have a similar shape. Full development of the fire is reached when temperatures exceed 500°C [3]. Failure times of the 10mm linings decrease as the fire load is increased, with a range difference of 6mins. The pictures of the house show that the wall lining that was facing the fire in the kitchen/lounge/dining room had failed i.e. was no longer in place, but the second wall lining behind the steel framing (10 + 10 = 20mm lining) was still intact. It is important to note that the 20mm failure times were not reached as the firemen had extinguished the fire well before these times could be reached. However it is not clear from this observation alone as to whether the fire exposed lining failed during the fire or as a result of fire service removal after the fire had been suppressed. To determine this, the condition of the visible steel framing has to be included in the considerations – similar appearance to the ceiling framing means the linings failed during flashover while a clean and

The analysis included different ventilation conditions to see how this would have affected the overall shape and temperature of the time-temperature curves. The curves in Figure 7 show higher temperatures than the time-temperature curves in both Figure 8 and Figure 10. This is due to the fact that there is more air available to fuel the fire and make it more intense. This model was considered as the critical one.

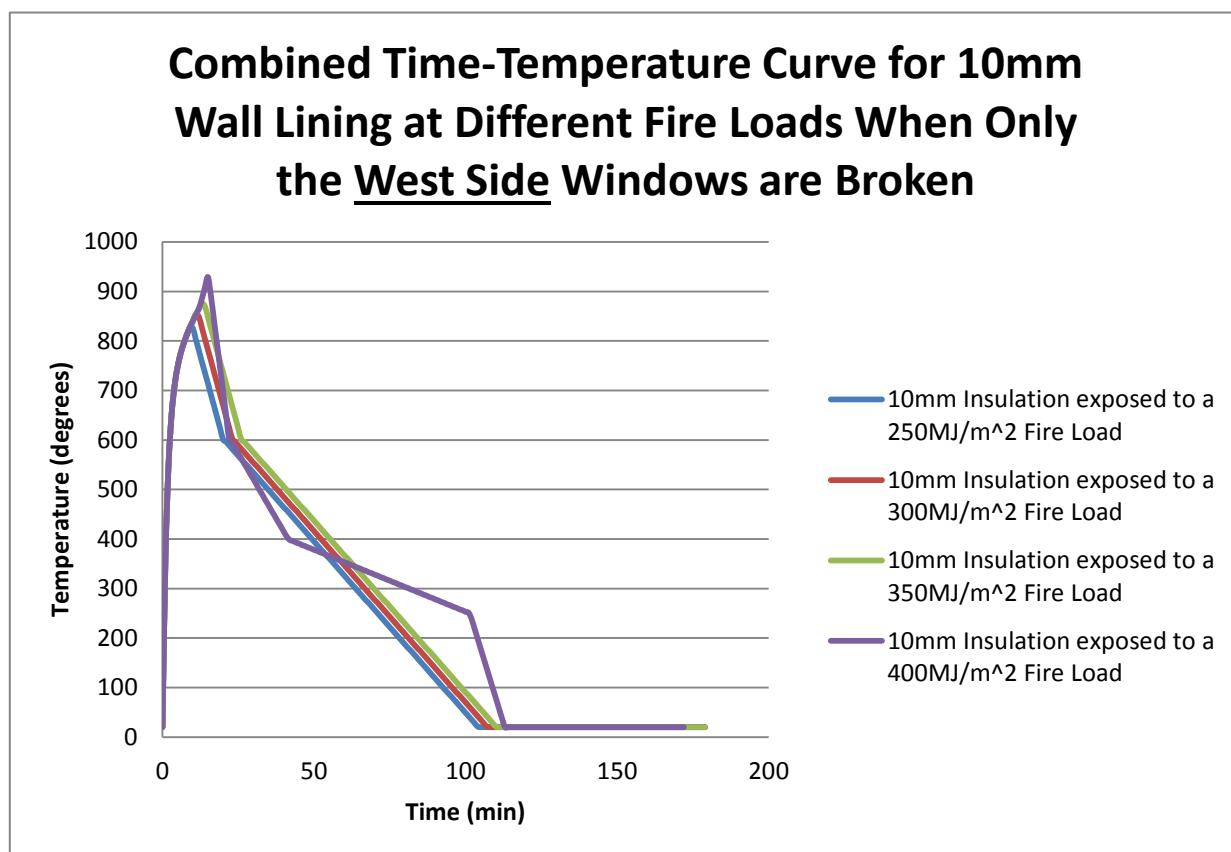
Figure 8: Time temperature curves and failure times for the Wall Lining when windows on the West Elevation are assumed broken

Figure 8 above shows the time-temperature curves for the 10mm wall lining and failure times for both the 10mm and 20mm wall linings at different fire loads when only the windows on the West Elevation of the house are assumed broken. Fire loads ranging from 250-350 MJ/m² have similar shape, however when analysing the fire load of 400 MJ/m², the change in ventilation due to the ceiling failing made the fire ventilation controlled as opposed to fuel-bed controlled which was seen in the other fire loads. This meant that in order to get the overall time-temperature curve, super positioning and shifting of the ceiling failure curve onto the wall failure curve was done hence the different shape. The time to failure for both the 10mm and 20mm wall linings decrease as the temperature increases. Peak temperatures ranged from 810°C - 910°C.

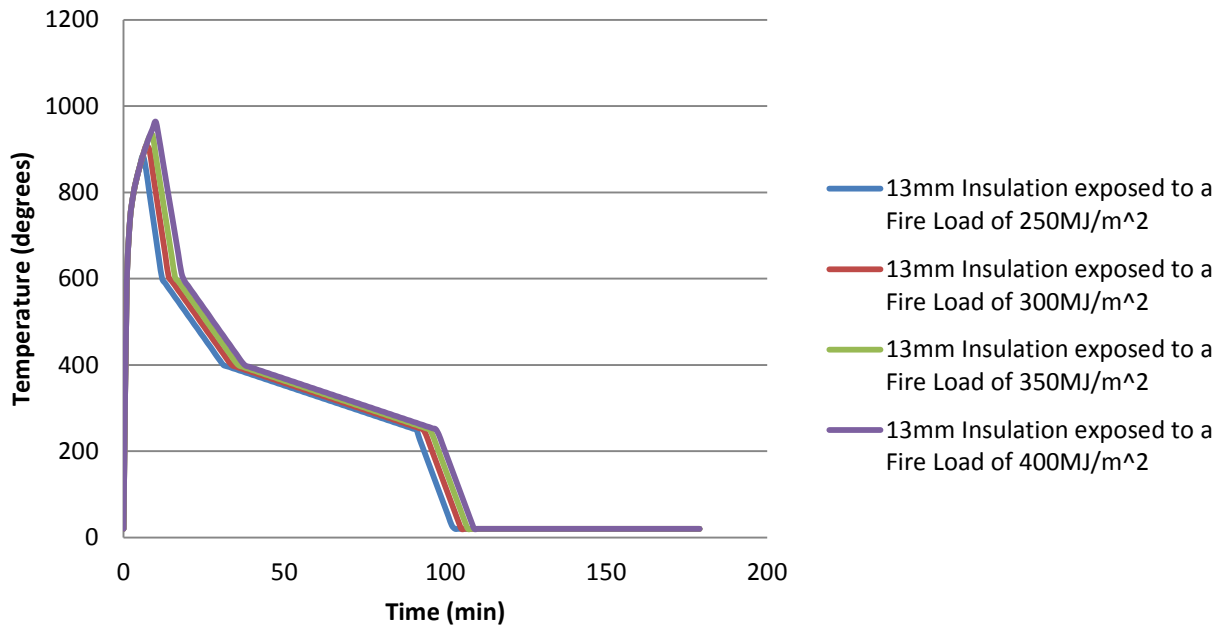
Figure 9: Time temperature curves and failure times for the linings in the ceiling when windows on the West Elevation are assumed broken

Figure 9 above illustrates the time-temperature curves and failure times for a 13mm ceiling lining at different fire loads respectively. The window on the west elevation was assumed to be broken. Observations from the graph indicate that an increase in fire load increases the peak temperature in the ceiling. Also, the ceiling failure times decreased as fire loads increased. All curves have similar shape with peak temperatures ranging from 860°C - 950°C.

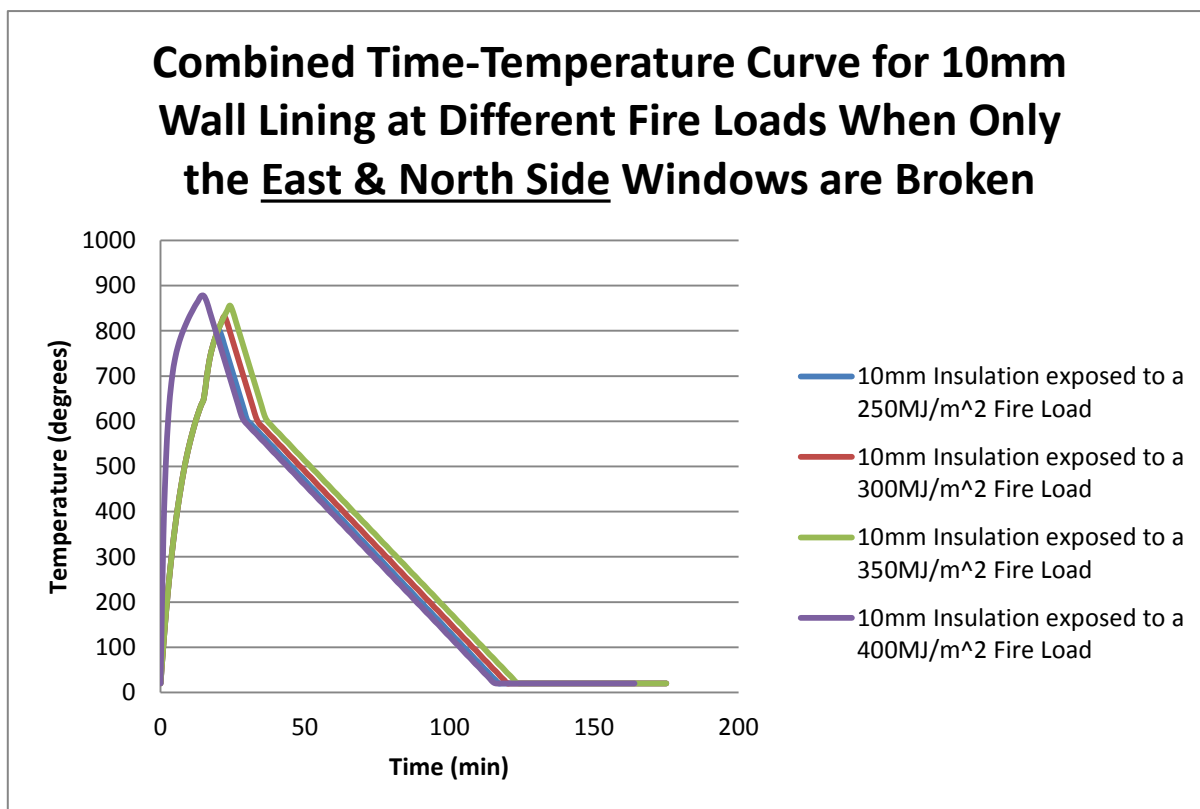
Figure 10: Time temperature and failure times when the windows on the East and North Elevations are assumed broken

Figure 10 shows the time-temperature curves for the 10mm walling and failure times for both the 10mm and 20mm wall lining when the windows of the living room at the east and north elevations are assumed to be broken. Peak temperatures at full development range between approximately 780°C – 880°C. The graphs for the fire loads of 250 – 350 MJ/m² have a similar shape as they are all fuel bed controlled. That is, the changes in ventilation conditions do not affect the curves. For the curve at 400 MJ/m², the shape is different. This is due to the fact that for this fire load, the change in ventilation conditions causes the fire to become ventilation controlled. Hence the curve shifting technique given in (Clifton, 1996) needed to be used to superimpose the ceiling failure curve and the wall failure curve.

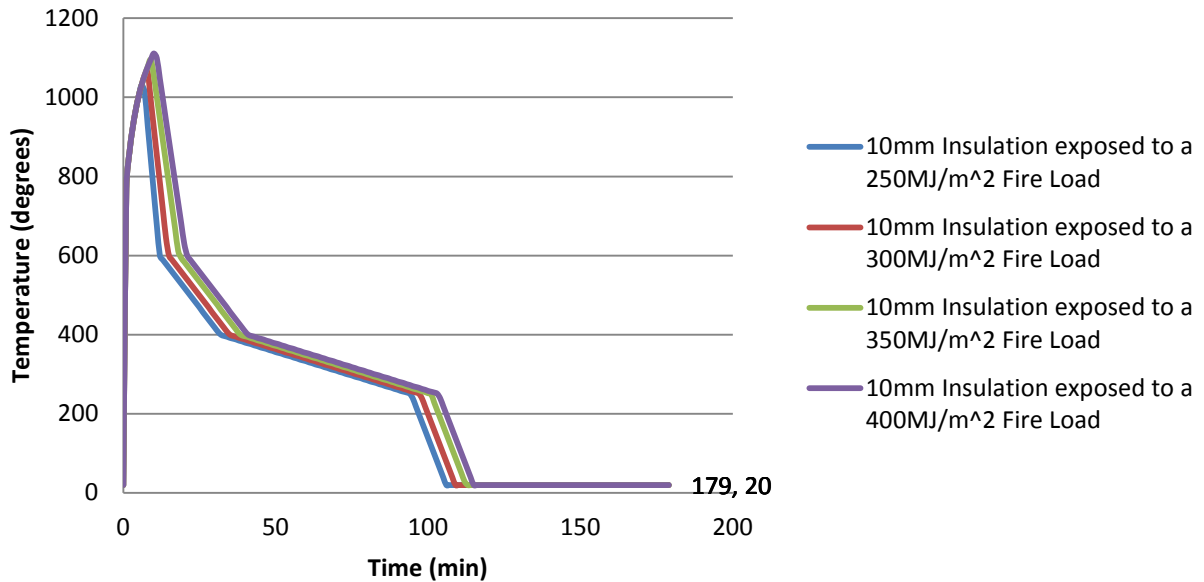
Figure 11: Time Temperature and Failure times for the wall lining when all windows are assumed broken at a thermal inertia of 700 J/m²Ks^{0.5}

Figure 11 shows the time-temperature curves of the 10mm wall lining and failure times of both the 10mm and 20mm wall lining assuming that all windows in the enclosure area are broken. This analysis was carried out with a thermal inertia of 700 J/m²Ks^{0.5} as opposed to 1160 J/m²Ks^{0.5} that was used on all other results. As before, the peaks of the time-temperature curves increase as the fire load increases and the failure times of the linings decrease as the fire load energy density increases. All graphs have the same shape indicating that they are all fuel bed controlled and thus no shifting was required.

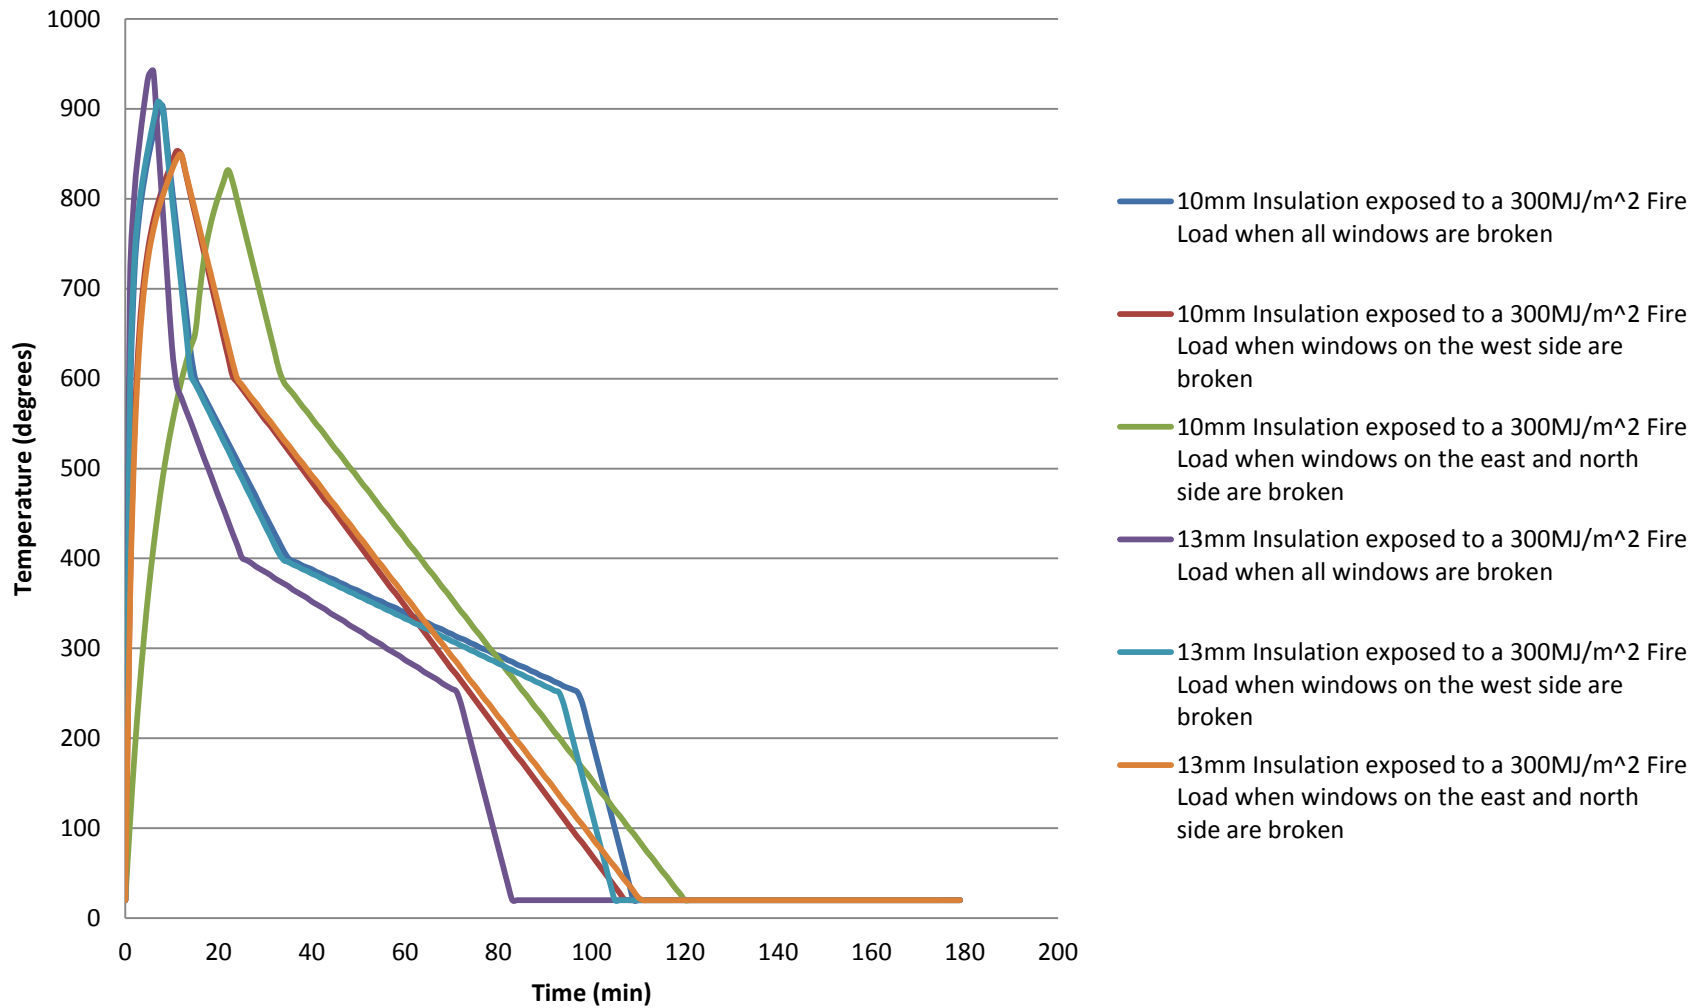
Figure 12: Time temperature curves for both the linings in the wall and ceiling at a fire load of 300 MJ/m²

Figure 12 shows the time-temperature curves for the linings in the wall and ceiling at a fire load of 300 MJ/m^2 for different ventilation conditions. The curves with the highest temperature have the most ventilation. This is seen in the condition where all the windows are broken. Another point that can be deduced is that the curves for the ceiling lining are at higher temperatures than the curves for the wall linings indicating that the ceiling would have failed first. The peak temperatures at full development range from 820°C - 940°C .

As the house was a standard built house, it was assumed that standard GIB was used in the ceiling and walls. The GIB in the ceiling and walls failed at temperatures of 120°C and 200°C respectively. From Figure 12 it can be seen that the ceiling would have failed before the wall. This is because the time-temperature curves for the ceiling were at higher temperatures than the ones for the wall lining.

MJ/m². Figure 12 shows comparisons of a 300MJ/m² fire for different ventilation conditions with the most critical case being when all the windows are broken.
